ReLine Prime

Collapsed Tubing Anchor Repair

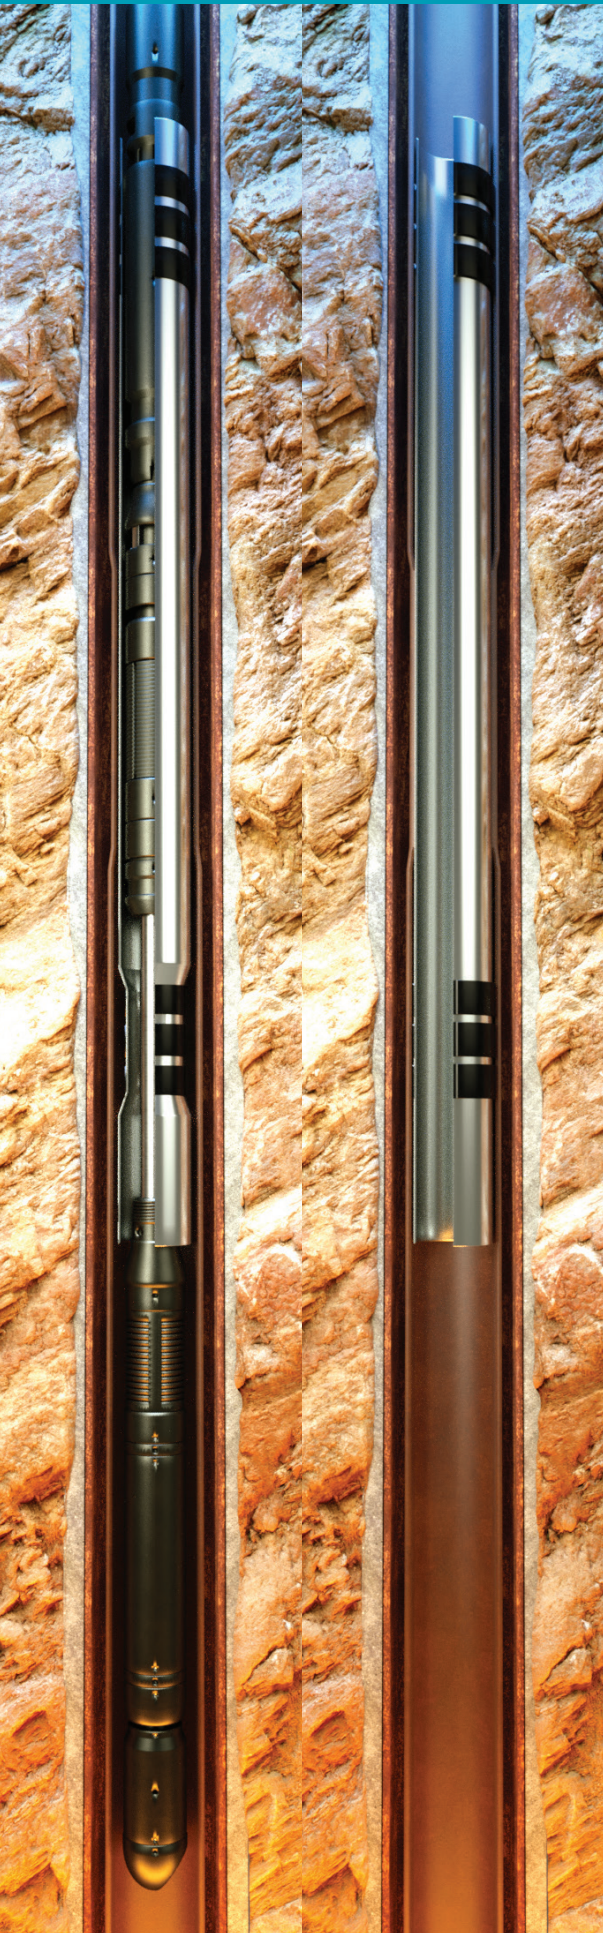
- Mohawk's premium cased hole patch system ReLine Prime enabled the operator to isolate the leaking tubing anchor and regain mechanical support to the 5 in. casing
- To handle planned frac loads, the operator required the casing patch to support 200,000 lb of tensile force and 11,000 PSI of internal pressure. These requirements were tested and verified prior to deployment.
- 3.880 in. OD seals were expanded to seal above the anchor while custom 3.700 in. OD recessed seals were used to drift the collapsed ID and seal below the failed anchor
- Special recessed seal joints can be utilized to drift and straddle various ID restrictions
