## ReLine Prime

# Saudi Aramco – Repairing Corroded Casing in an Injection Well

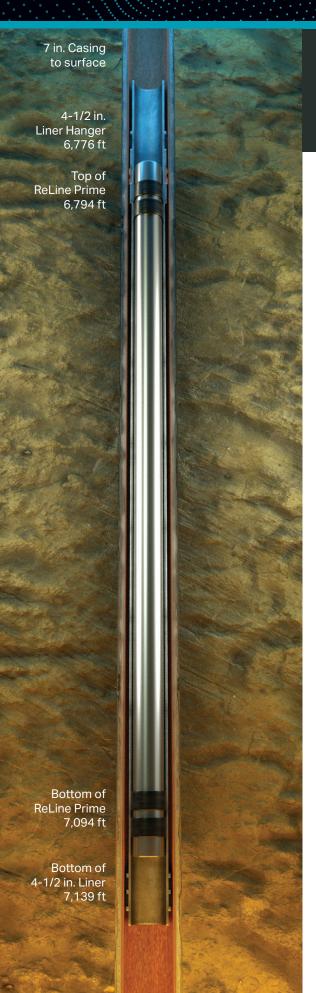
After reviewing corrosion logs of this vertical injection well, a significant anomaly was observed indicating up to 57% metal loss at 7,005 ft across a 4-1/2" liner. In anticipation of further corrosion, it was necessary to isolate this section of casing.

- Coretrax's premium cased hole patch system ReLine Prime was selected to cover and mechanically isolate the corroded interval.
- Coretrax was allowed 3 days to prepare and implement a solution.
- Premium expandable connections allow the expandable patch to be assembled as long or as short as required.
- The ReLine Prime system has been pressure tested and is capable of withstanding pressures of over 10,000psi.
- The expandable liner used with the ReLine Prime system has been tested under NACE protocol and is H2S resistant.
- The ReLine Prime system utilizes a unique running tool that eliminates the need for a conventional aluminum shoe on the bottom of the patch.

- The expandable patch was successfully deployed and expanded in one trip with no shoe drill out.
- All significant corrosion was mechanically isolated under the ReLine Prime expandable liner.
- A large expanded patch ID of 3.416" was achieved by expanding both the pipe body and connections allowing for a packer to be set inside or below the patch.
