# ReForm

## ReForm Case History - PNG

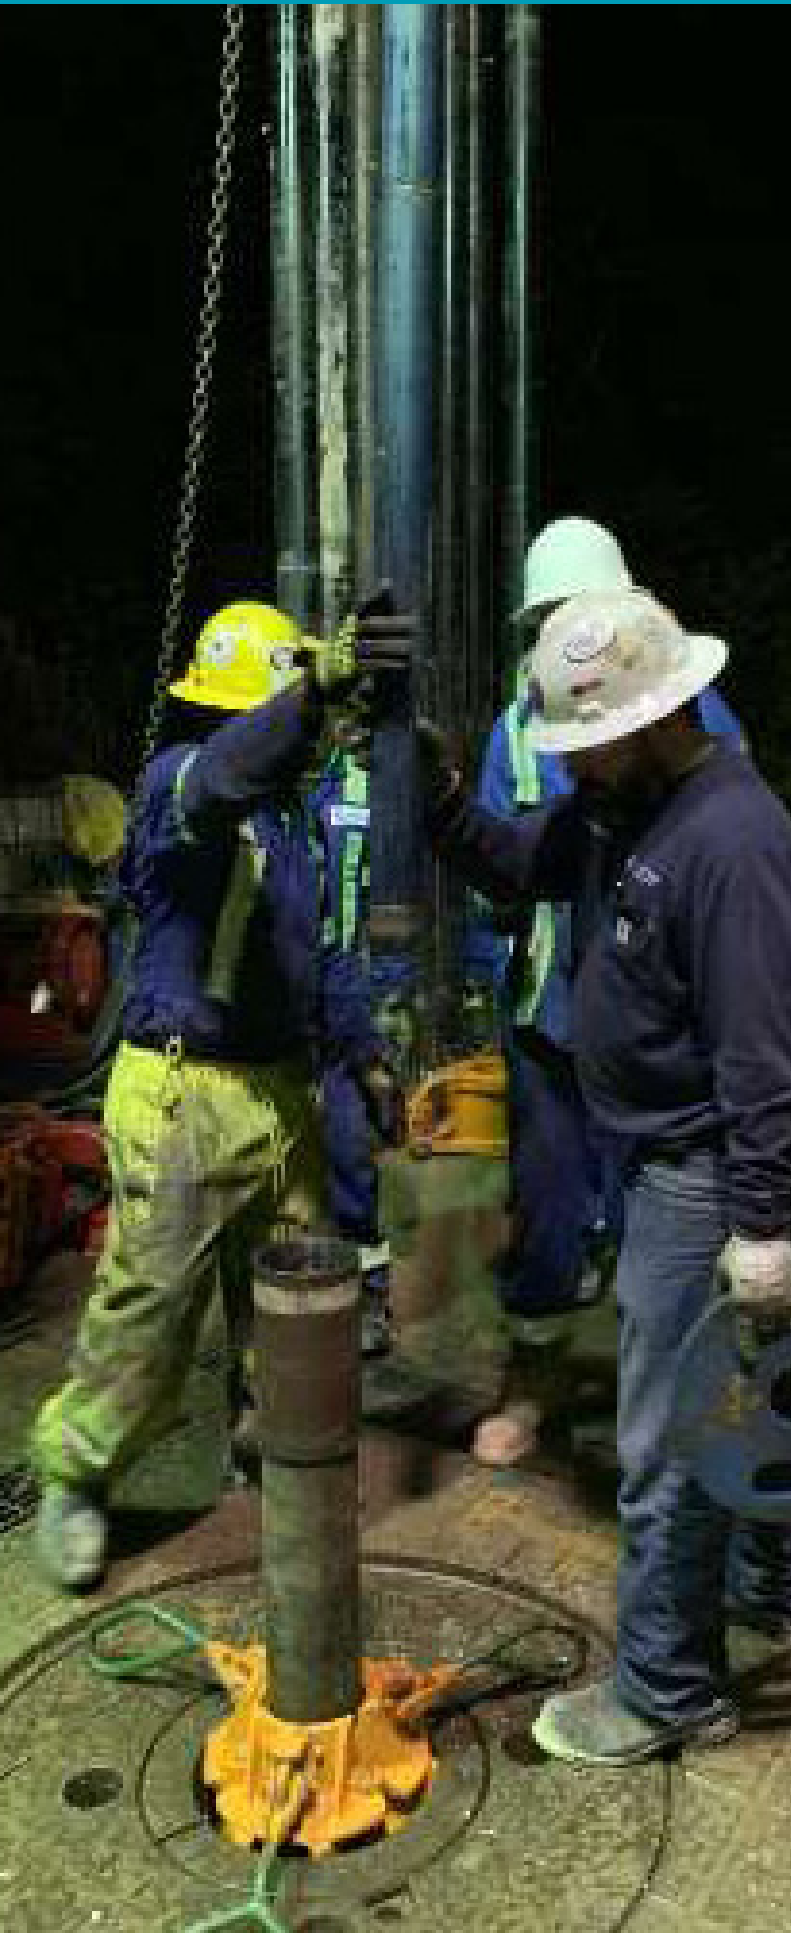
The collapse began at 9m RKB, ~2m below ground level, and was of unknown length. Production packer and/or injection valve was leaking – and due to collapse, wireline intervention could not access below collapse to determine leak path. Corrosion/erosion may have affected the tubing in this area, and the tubing was determined to have collapsed with effectively no gap, "pinched flat" The Coretrax ReForm solution was selected due to its ability to apply upwards of 200,00lbs of surface controlled downward force at the Cone.

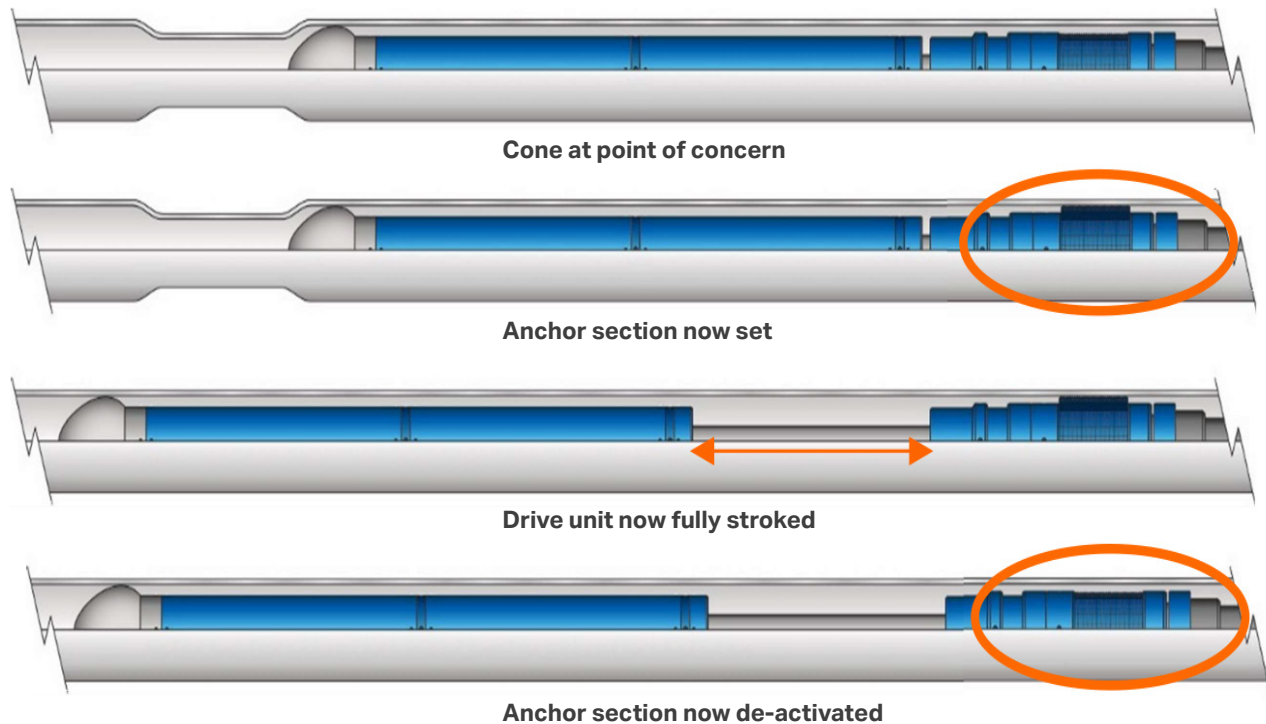
1. Make up landing joint for ID Anchor to bite
2. Provide removable pressure cup above tool to direct flowback to flowline while tool across BOPs
3. Provide two sizes of drive units for two-pass forming of the tubing (intermediate and full drift) to reduce forces
4. 3.250" and 4.760" Cones selected for compatibility with drive units and cutter pass through requirements
5. Small OD tool was picked up and RIH to top of collapse at 10m -- Stroked with 3.250" Cone
6. Free movement down to 15m, POOH
7. Cutter could not pass, 2-7/8" tubing could not pass
8. Large OD tool picked up and tagged at 10m --Stroked 2x with 4.760" Cone
9. Small OD tool run in and tagged at 17m -- Stroked with 3.250" cone
10. Free travel to 20m
11. Large OD tool run to 17m -- Stroked 2x with 4.760" cone
12. Free travel down to 29m
13. RIH with cutter
