# DAV MX™

## 250bbls of 16.6ppg cement slurry successfully displaced through DAV MX™ CircSub to treat Severe losses at 28,170ft on a Gulf of Mexico Deep Water well.

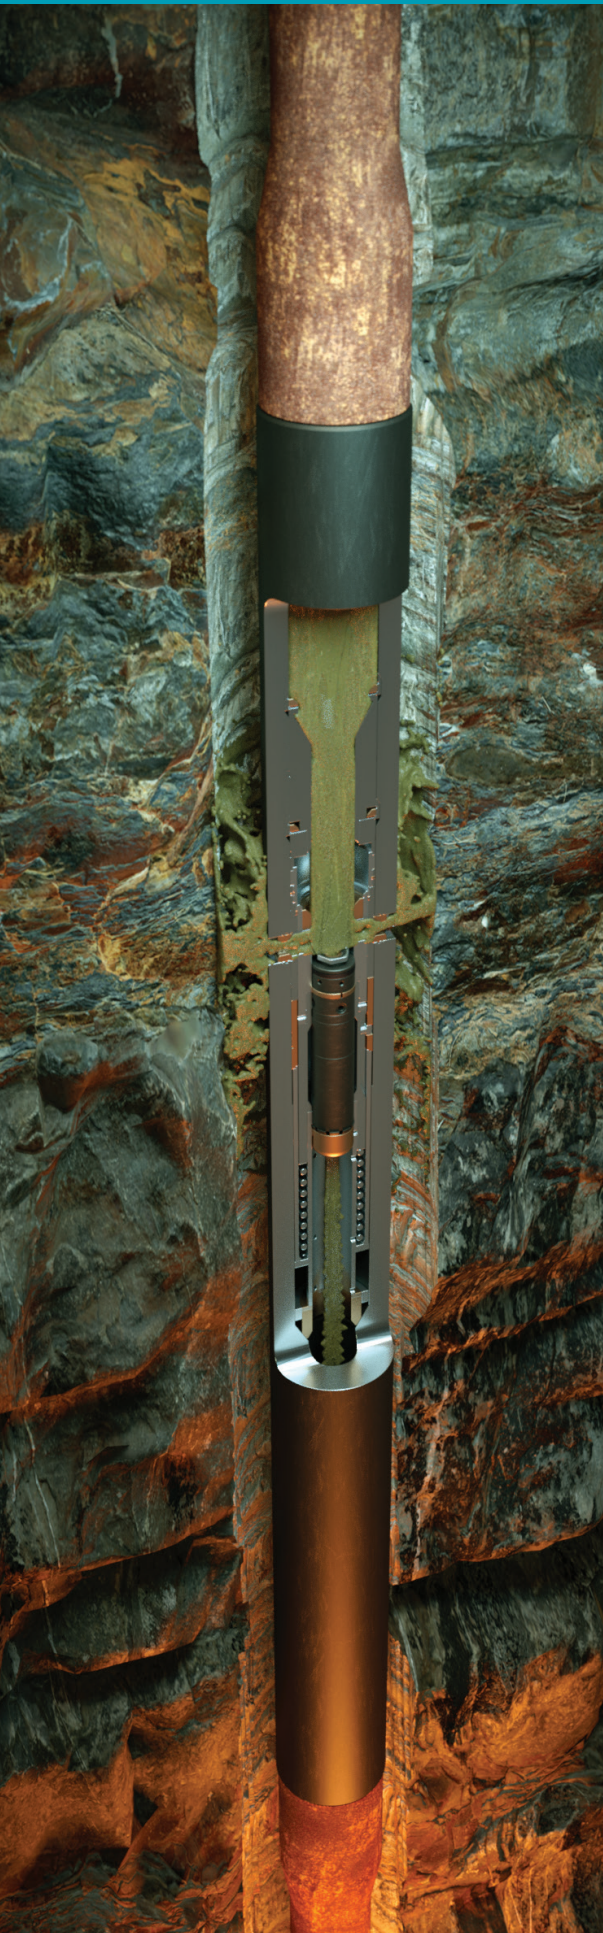
● <b>Tool</b>	8.00" OD, 6-5/8" Reg DAV MX™ CircSub with five standard OD nozzles (0.75")
● <b>Activator</b>	1 x SDD
● <b>Application 1</b>	Treating losses with LCM (331bbls at 105ppb)
● <b>Application 2</b>	Tool still in bypass, treating losses with 250bbls of 16.6ppg Cement

The DAV MX™ Circsub was opened to bypass the lower BHA allowing cement slurry to be pumped through the Circsub ports. The latch and seal mechanism of the SDD ensured a full bypass and no cement ingress into the lower BHA. Because the SDD locks the valve open, it allows losses to be treated at lower circulating rates (pumping hard can make losses more severe) whilst ensuring the ports are fully open (max TFA) thus reducing any plugging risk. In this particular case it allowed treating losses with 250bbls of 16.6ppg cement slurry displaced through the standard ports at 9 bpm. Because you can treat with cement through the DAV MX™ Circsub, it can potentially save an Operator a trip out of hole if the treatment proves successful.
