# OnePatch

## Alaska – Isolation of Water Ingress

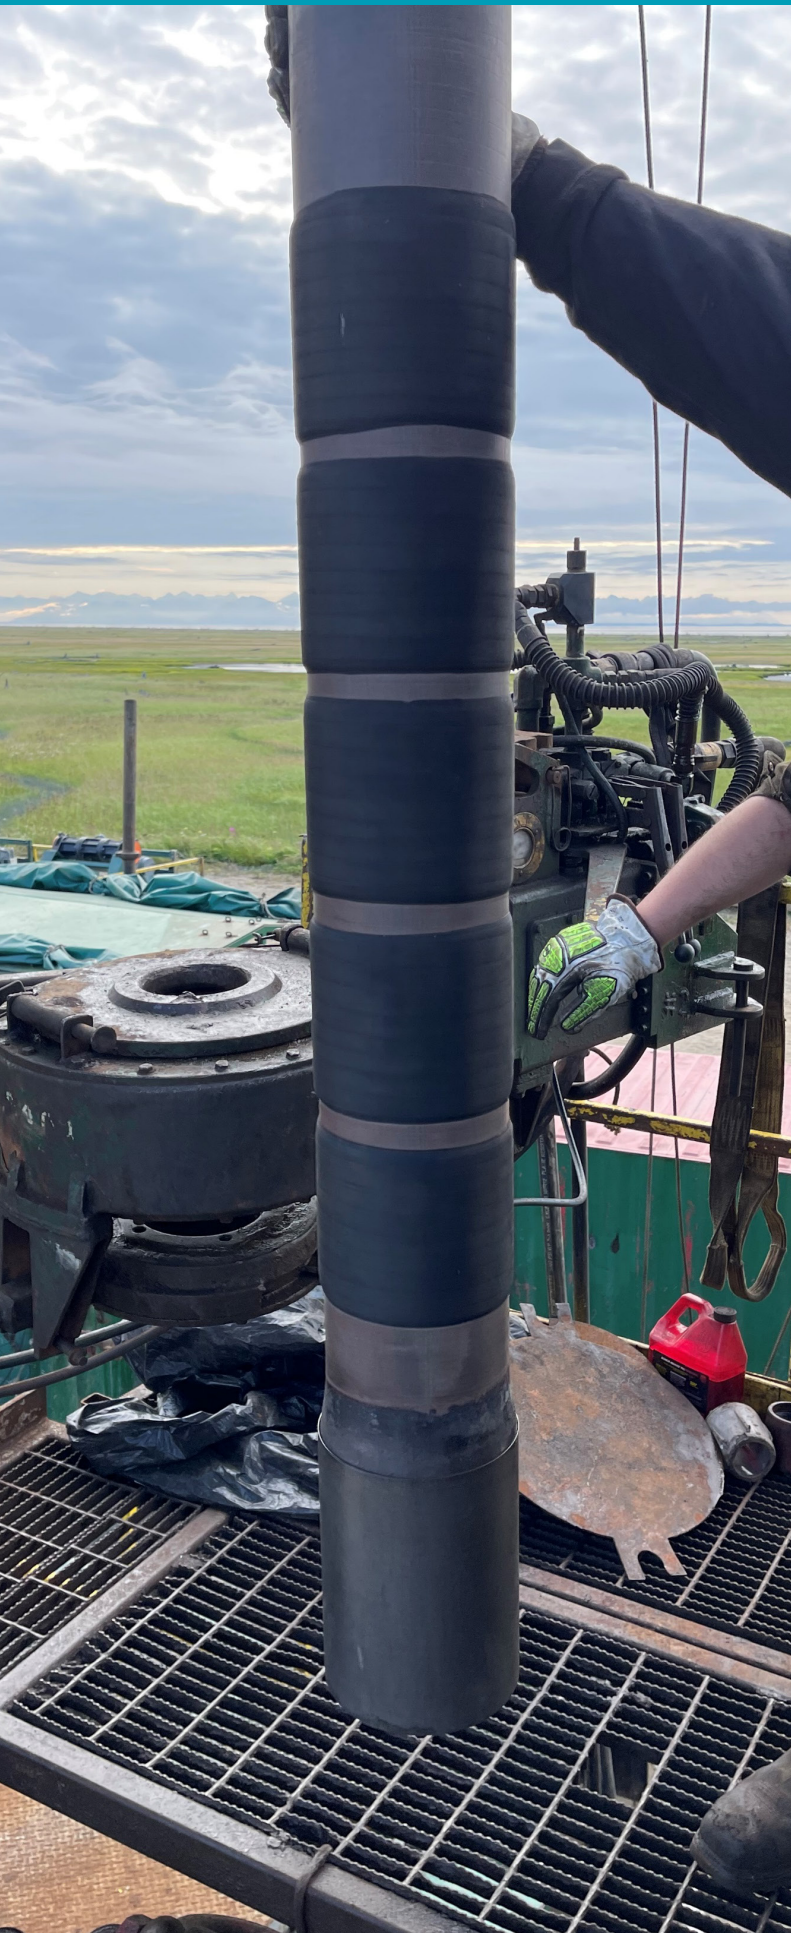
Our 36ft 7" 26# OnePatch was deployed, expanded and tested successfully across the water producing zone at 6279' to 6292. Our post expansion ID of 5.521" outperforms any other solution on the market for this casing size, enabled optimised production liner selection, and alleviated any concerns with resultant cementing ECD's for Liner installation.

The well data was analysed and our 36ft 7" 26# OnePatch was selected as the optimal solution. OnePatch is a 'rig ready' solution to isolate various wellbore integrity issues. Its compact design and simple operation enable repairs to be made efficiently, significantly reducing operational expenditure.
